Treerepairs
12 Gore Street,
Greenwich, NSW, 2065
treerepairs@gmail.com
Mobile: 0449610919
ABN: 17441140433

SITE REF: 2 Lovell Road, Eastwood NSW.
ATT: Ryde Council Tree Management Team

This letter provides a summary of a Visual Tree Assessment (VTA) performed on 2 x Brushbox (*Lophostemon confertus*) growing adjacent to a large 'fuel pricing sign' at the 'Mini Stop Convenience'. Refer to Image 1 for further details.

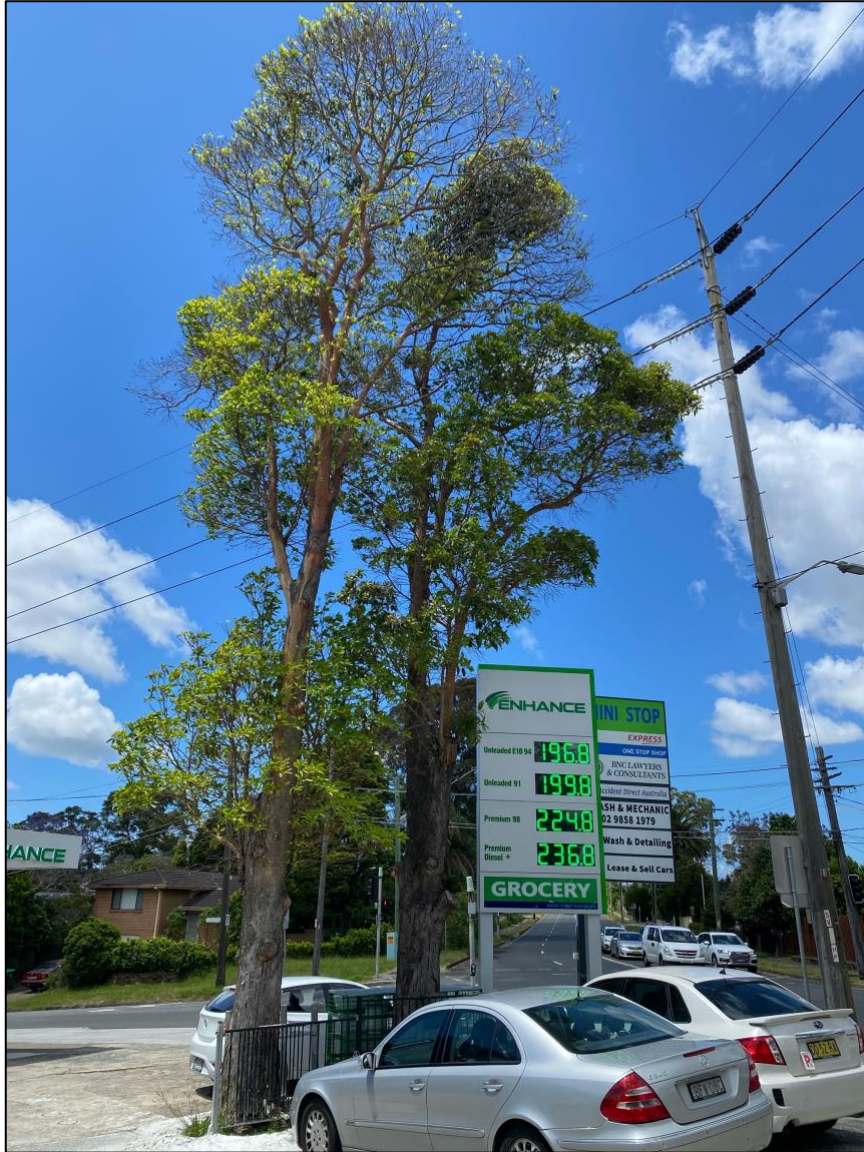
IMAGE 1: Subject trees growing in close proximity to the 'fuel pricing sign' (N. Maynard 08/11/22).

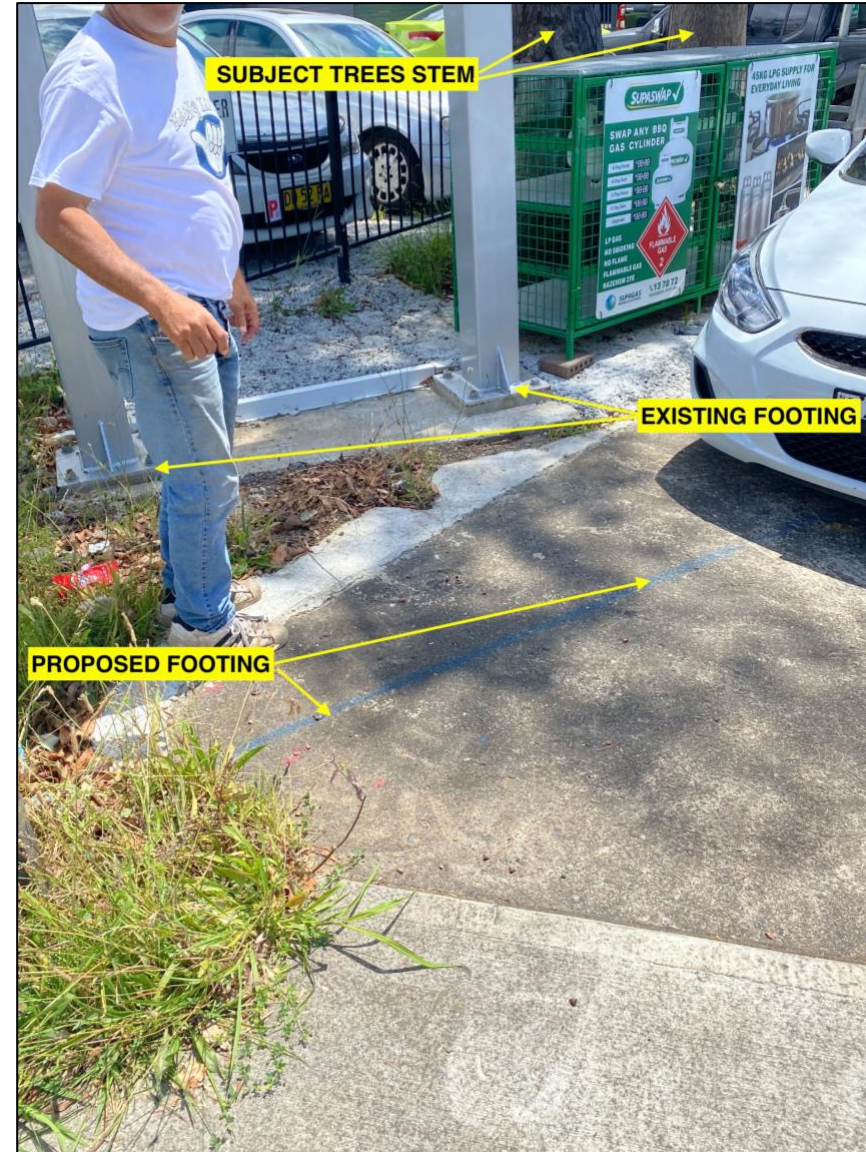
IMAGE 2: Proposed footings are in same radial spread but further away from tree stems than the existing footings (N. Maynard 08/11/22).

- Treerepairs recommends that the existing footings be demolished under minimum AQF3 Arborist supervision.
- The removal of existing footing will leave a significant hole in the ground. It is recommended that the hole be back filled immediately with mixture of soil and aggregate to promote new root growth into this zone.
- If any significant transport roots (greater than 30mm in diameter) are encountered during excavation for the new footing they are to be pruned immediately to Australian Standard 'AS:4373-2007' Pruning of Amenity Trees' by minimum AQF3 Arborist.

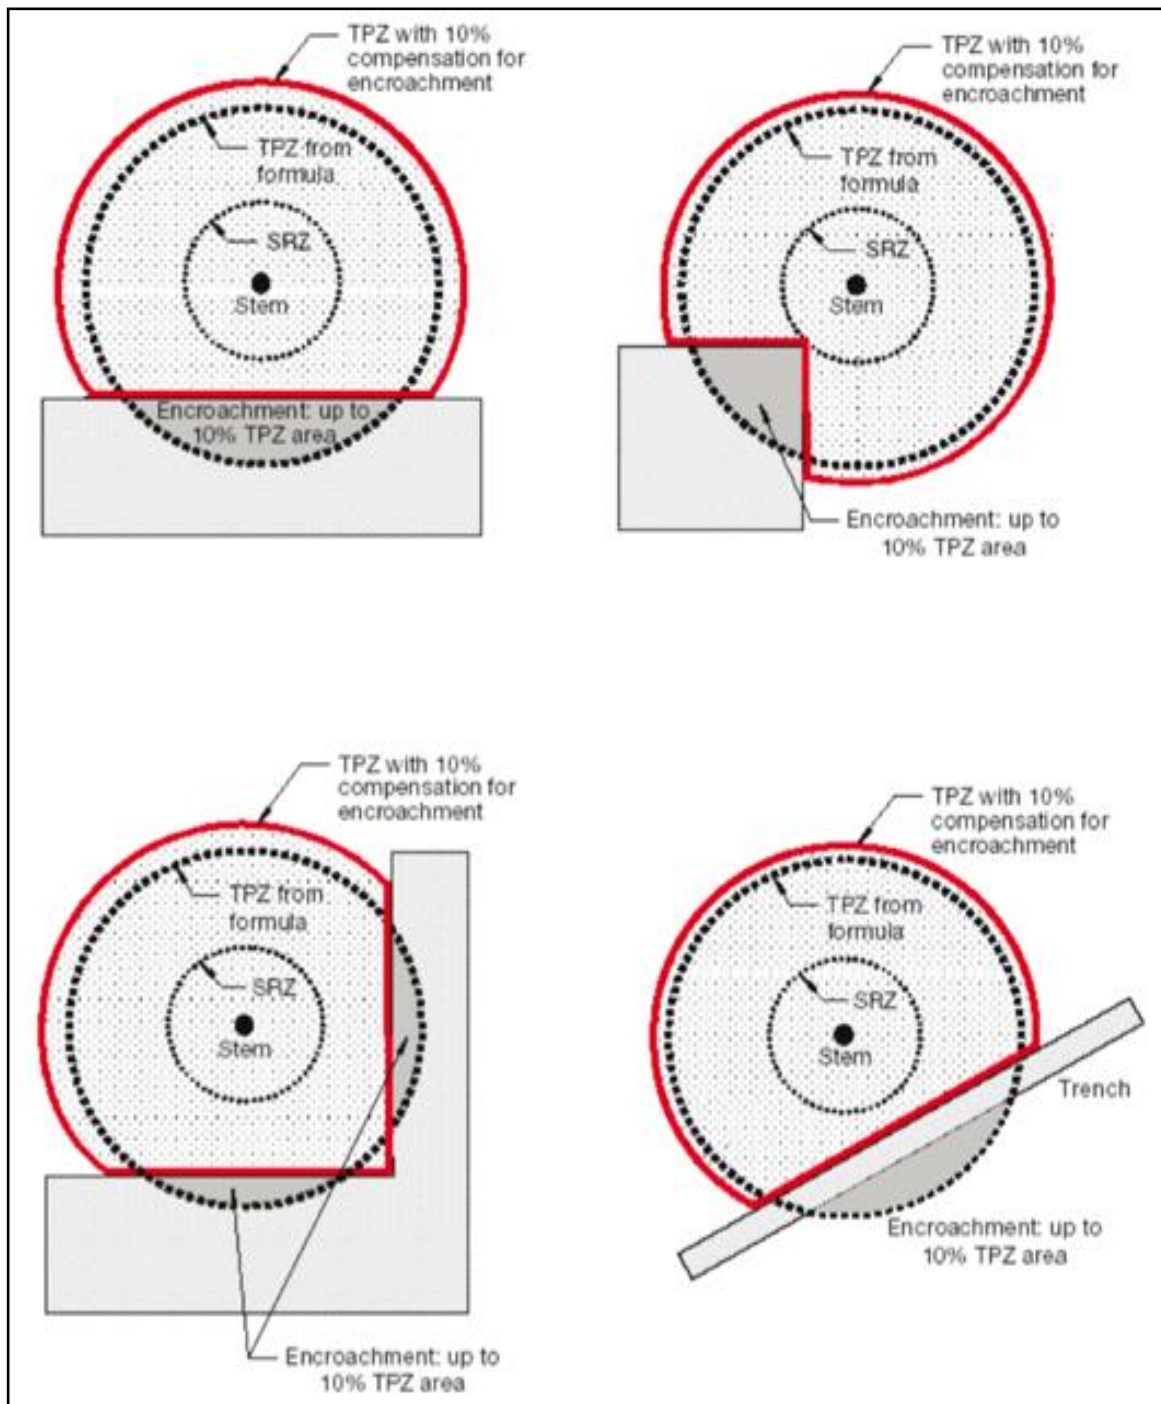
- The subject trees are exhibiting fair health and fair vitality.
- The subject trees Structural Root Zone (SRZ) has been calculated at 2.47mt.
- The subject trees Tree Protection Zone (TPZ) has been calculated at 6.00mt.
- The proposed footing is in the same radial zone of the subject trees except it is to be constructed further away from the tree stem base than the existing footing. Refer to Image 2 for further details.
- The proposed footing demolition and construction works are outside the calculated SRZ and within the subject trees calculated TPZ.
- The calculated encroachment area is less than 10% of the subject trees calculated TPZ and is considered acceptable using the Australian Standard 'AS:4970-2009 Protection of Trees on Development Sites'. Refer to Figure 1 for further details.

FIGURE 1: Examples of minor TPZ encroachment (Sourced AS:4970-2009).
