Re: Environmental Assessment – 2 Lovell Road, Eastwood NSW

Attachment 1 - Site Photos

Spray Painting Booths Inspection Report

According to AS/NZS 4114.2:2020

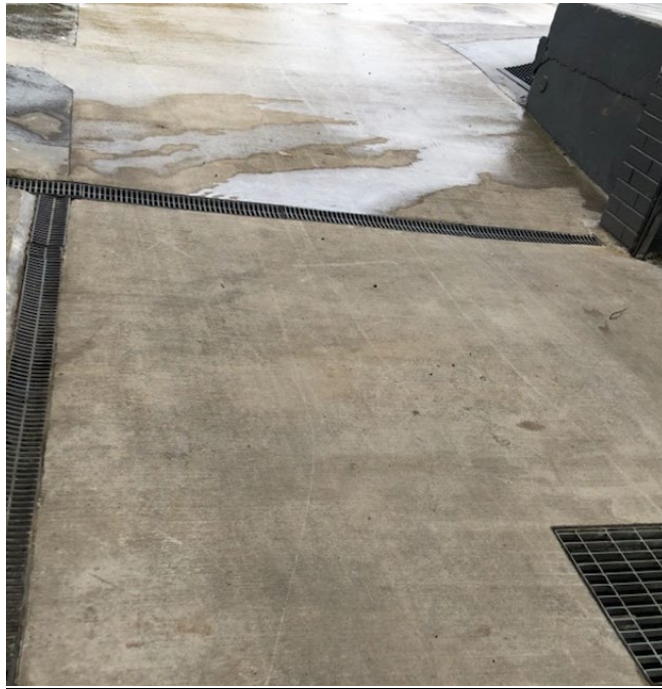
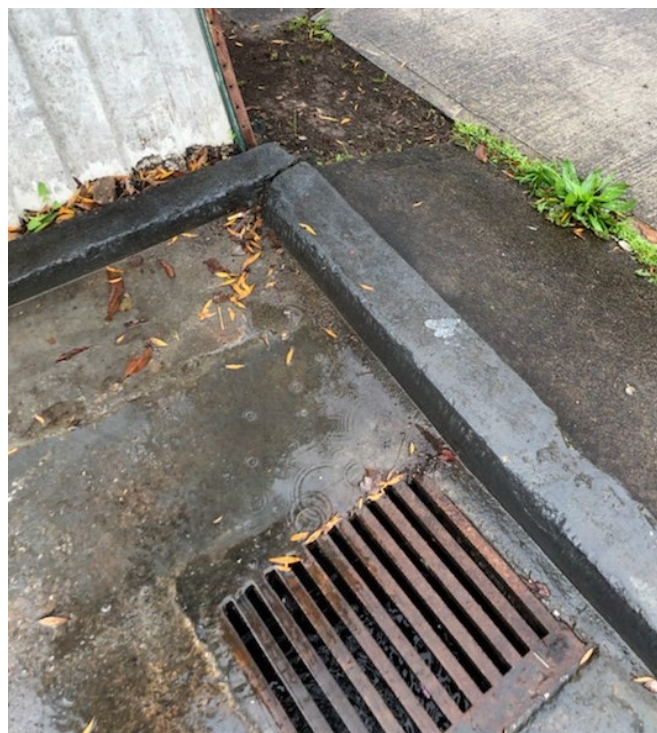
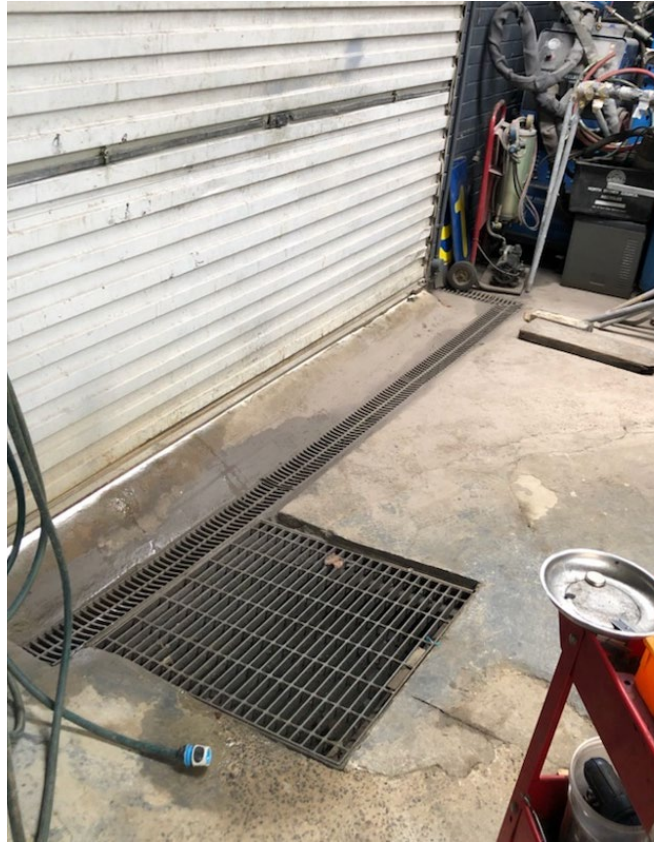
- Stormwater pathways were noted to be collecting water. It was noted that significant water flow was entering the stormwater system.
- Repairs had been recently undertaken by a plumber and new stormwater pits had been installed.
- All stormwater runoff from the street is directed into the council stormwater system and diverted from the site into stormwater system.
- Internal pits all flow towards the oil water separator and is disposed of as trade waste.
- Accidental discharge points were not identified that lead to the neighbouring property.
- No surface water was that was from within the building (and hence potentially carry contaminants) was observed running off the site into the neighbouring property during the inspections. This water was intercepted by internal pits.

Based on the inspection undertaken within the site and the mitigation works that have been undertaken, it is unlikely that contaminated surface water spills occur from the site.

It is recommended that inspections are carried out on a yearly basis or upon notice of significant deterioration in site conditions. It is also recommended that stormwater drainage points be inspected after significant amounts of rainfall within the area in order to ensure the function of the drainage system.
