PRELIMINARY SITE INVESTIGATION

Prospective Child Care Centre
16 Terry Road Eastwood NSW

Project Reference	CA/23/169-7001
Project Name	Conduct of a Preliminary Investigation of a Prospective Child Care Centre Development Site at 16 Terry Road NSW
Document Title	Preliminary Site Investigation: Prospective Child Care Centre 16 Terry Road Eastwood NSW – Version 2; October 23 rd , 2023
Document Reference	Eastwood – 16 Terry Road Preliminary Site Investigation Report (Version 2) – 231023.docx
Issue Type	Electronic
Attention	Mr Irving Zhong

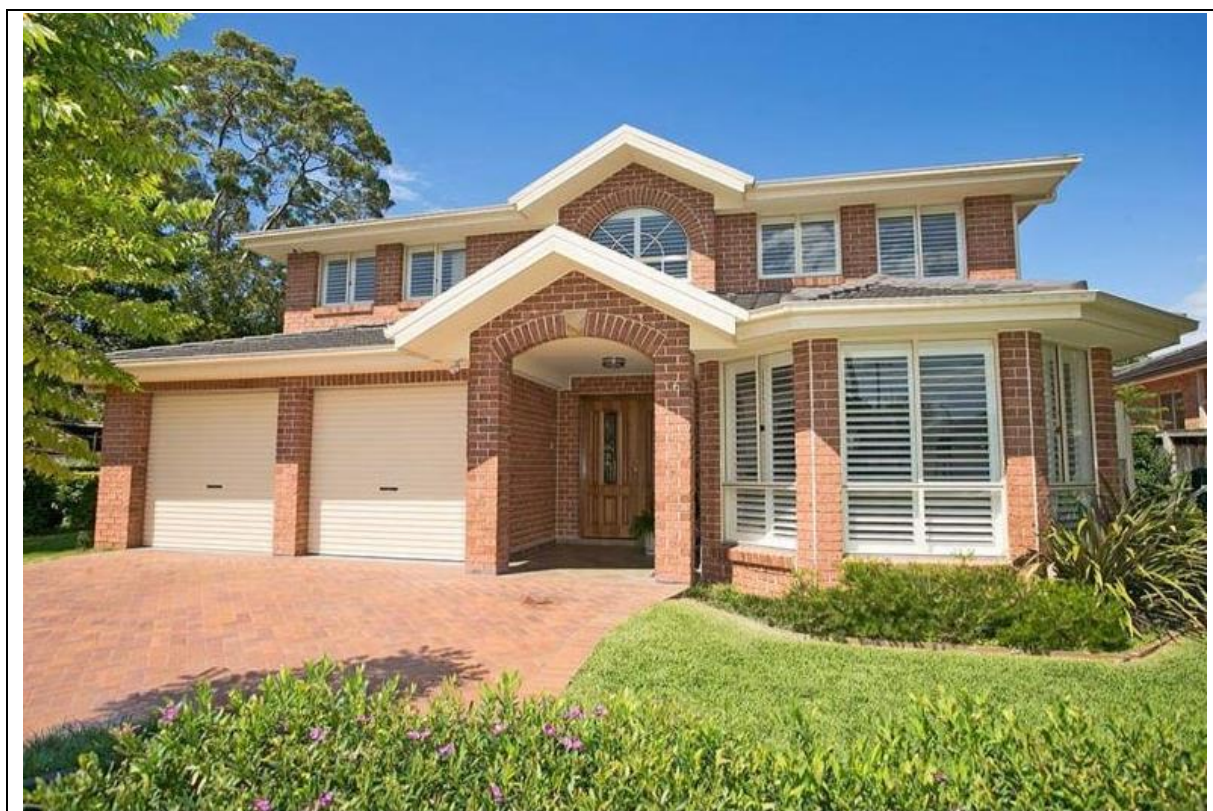
Figure 1.3 – Site Viewed from Terry Road

A view of the site and the existing residential dwelling present at the site, viewed from Terry Road, is provided in Figure 1.3, below.

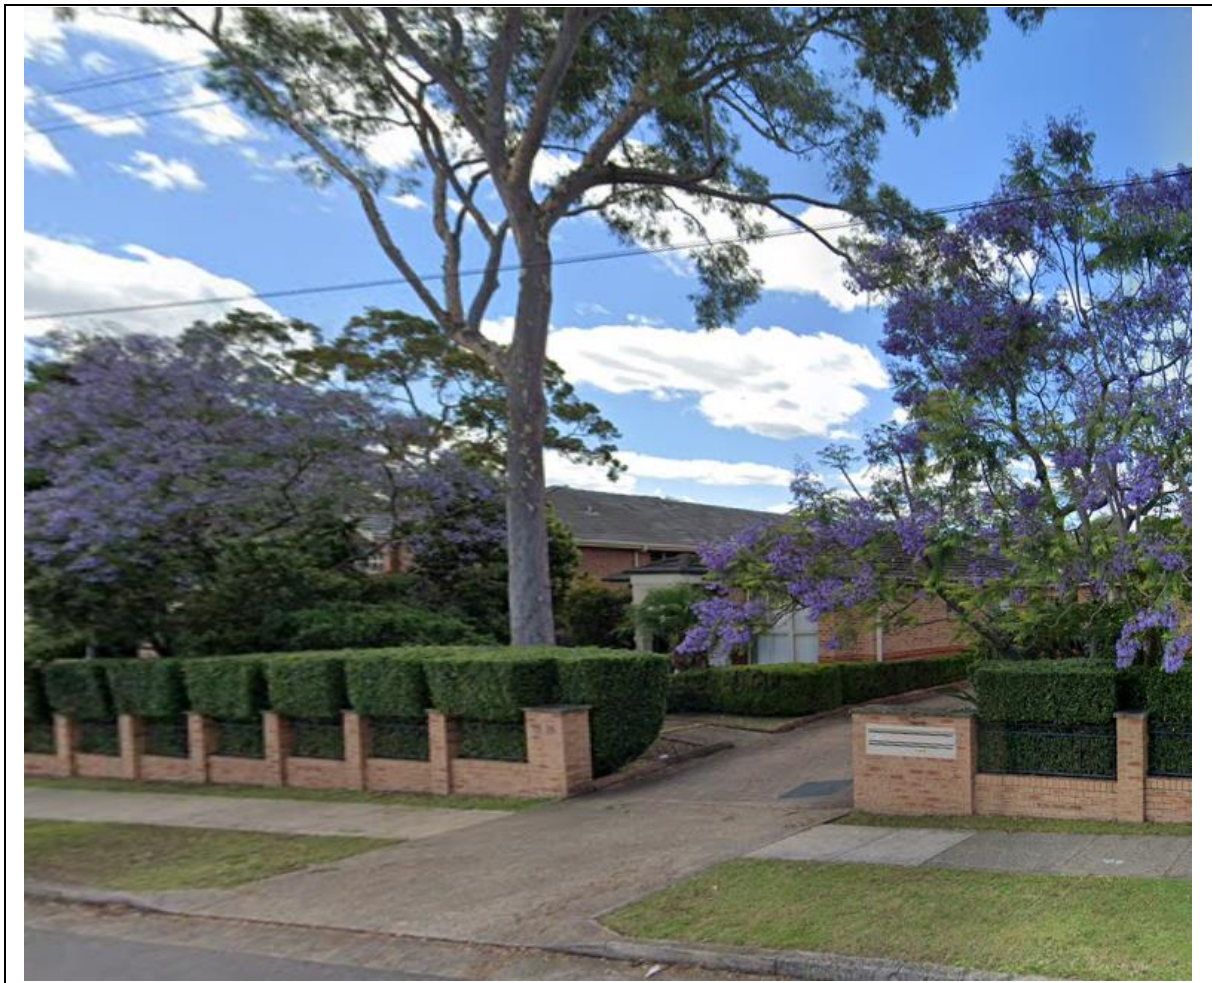
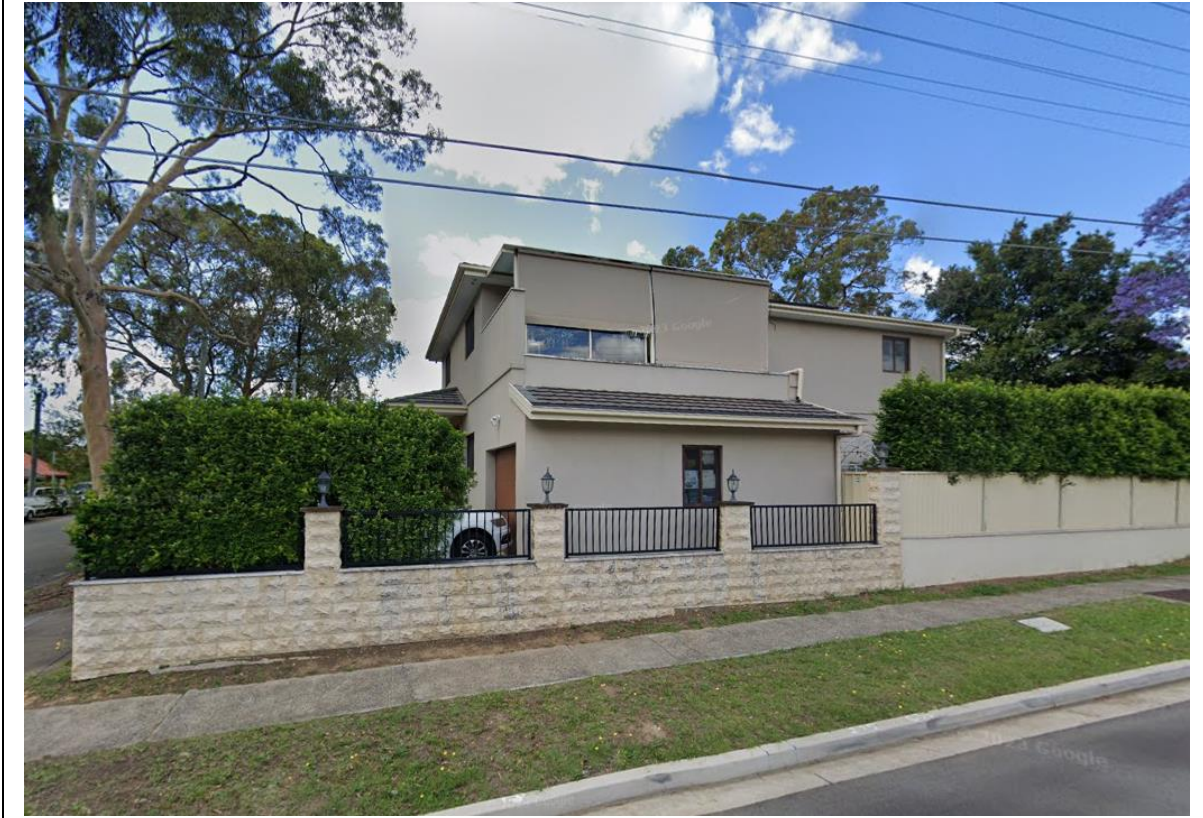
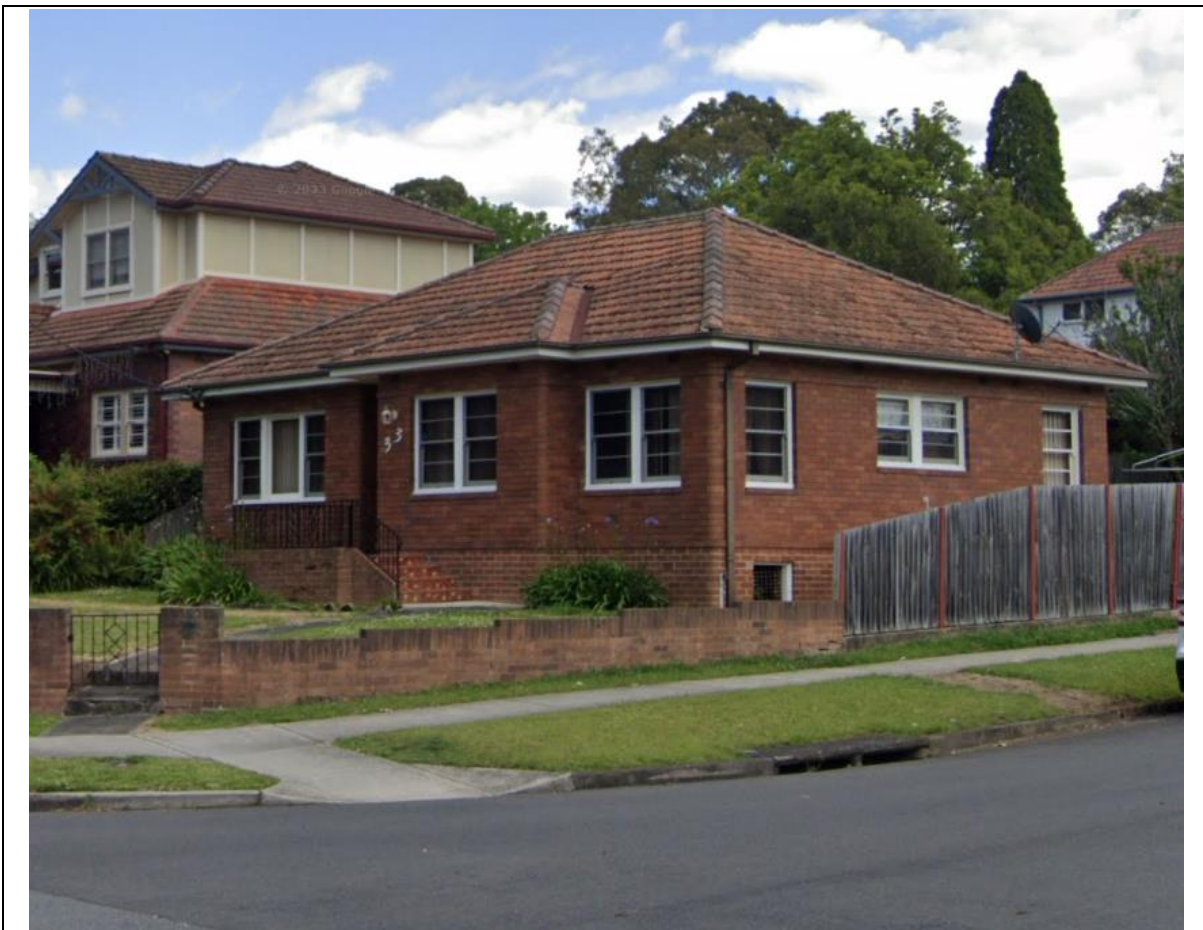
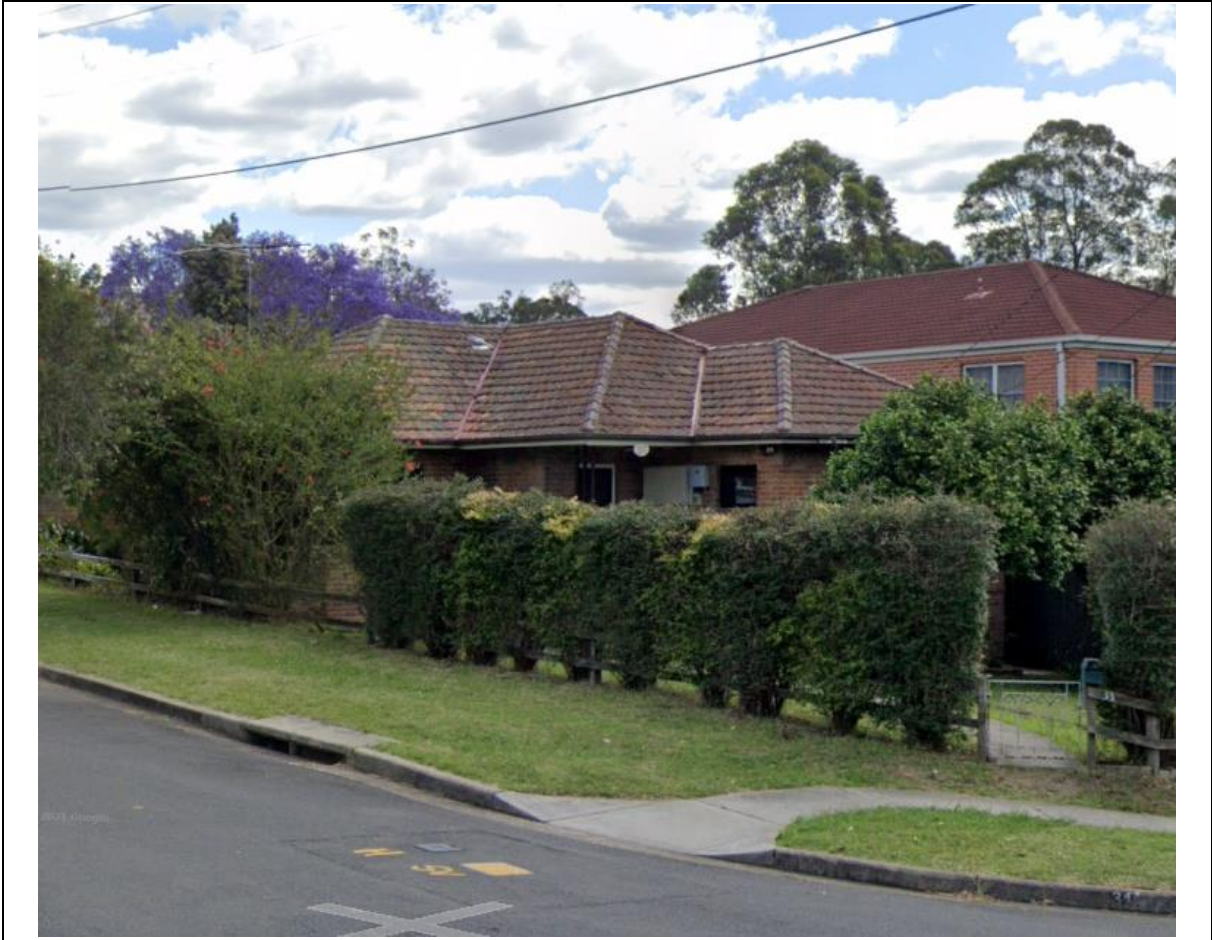
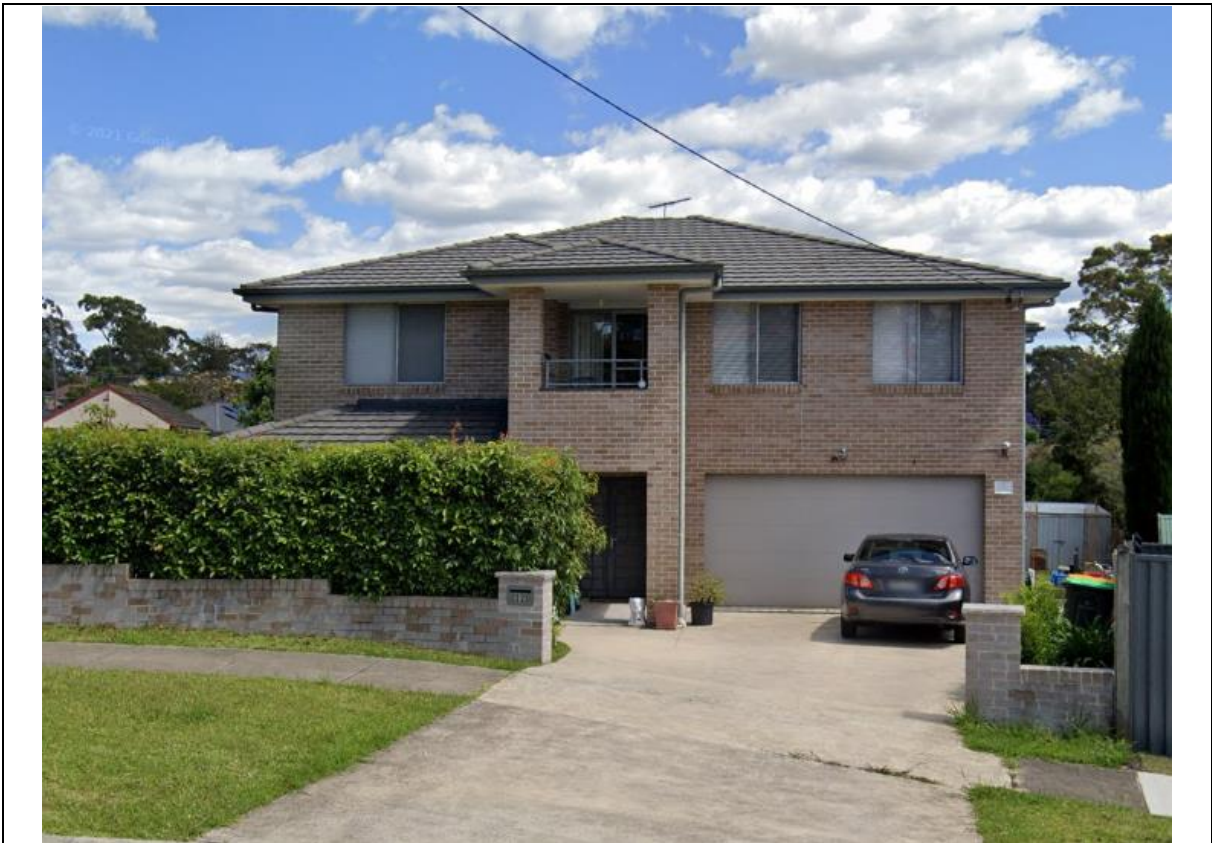
Photographs of the surrounding properties are provided in Figures 6.1 to 6.5, below and on subsequent pages.

Surrounding properties and activities are exclusively residential, and no environmental or contamination risks or exposures are indicated.

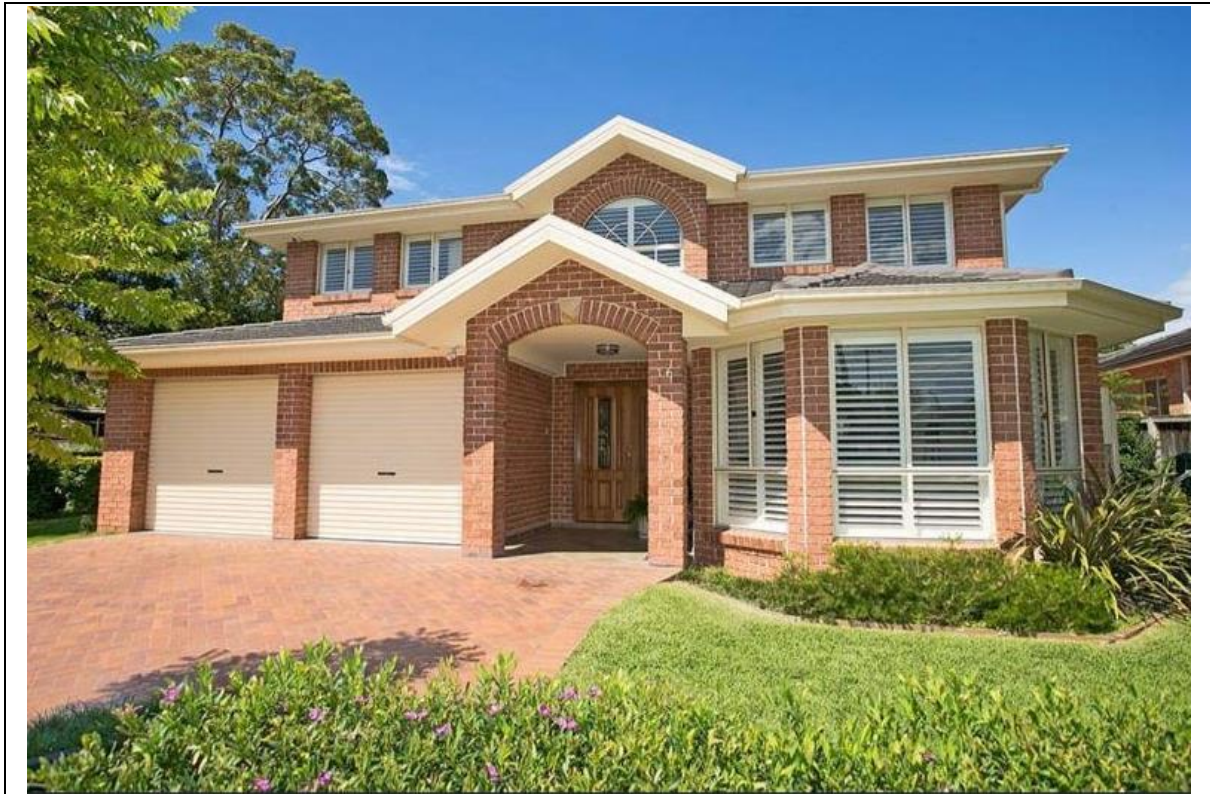
Figure 6.6 – Existing Dwelling at 16 Terry Road

The existing residential dwelling located on the 16 Terry Road Eastwood site is shown in Figure 6.6.

The dwelling at the site is of recent construction, and provides no indication of any issues likely to involve environmental or contamination hazards, risks or exposures.

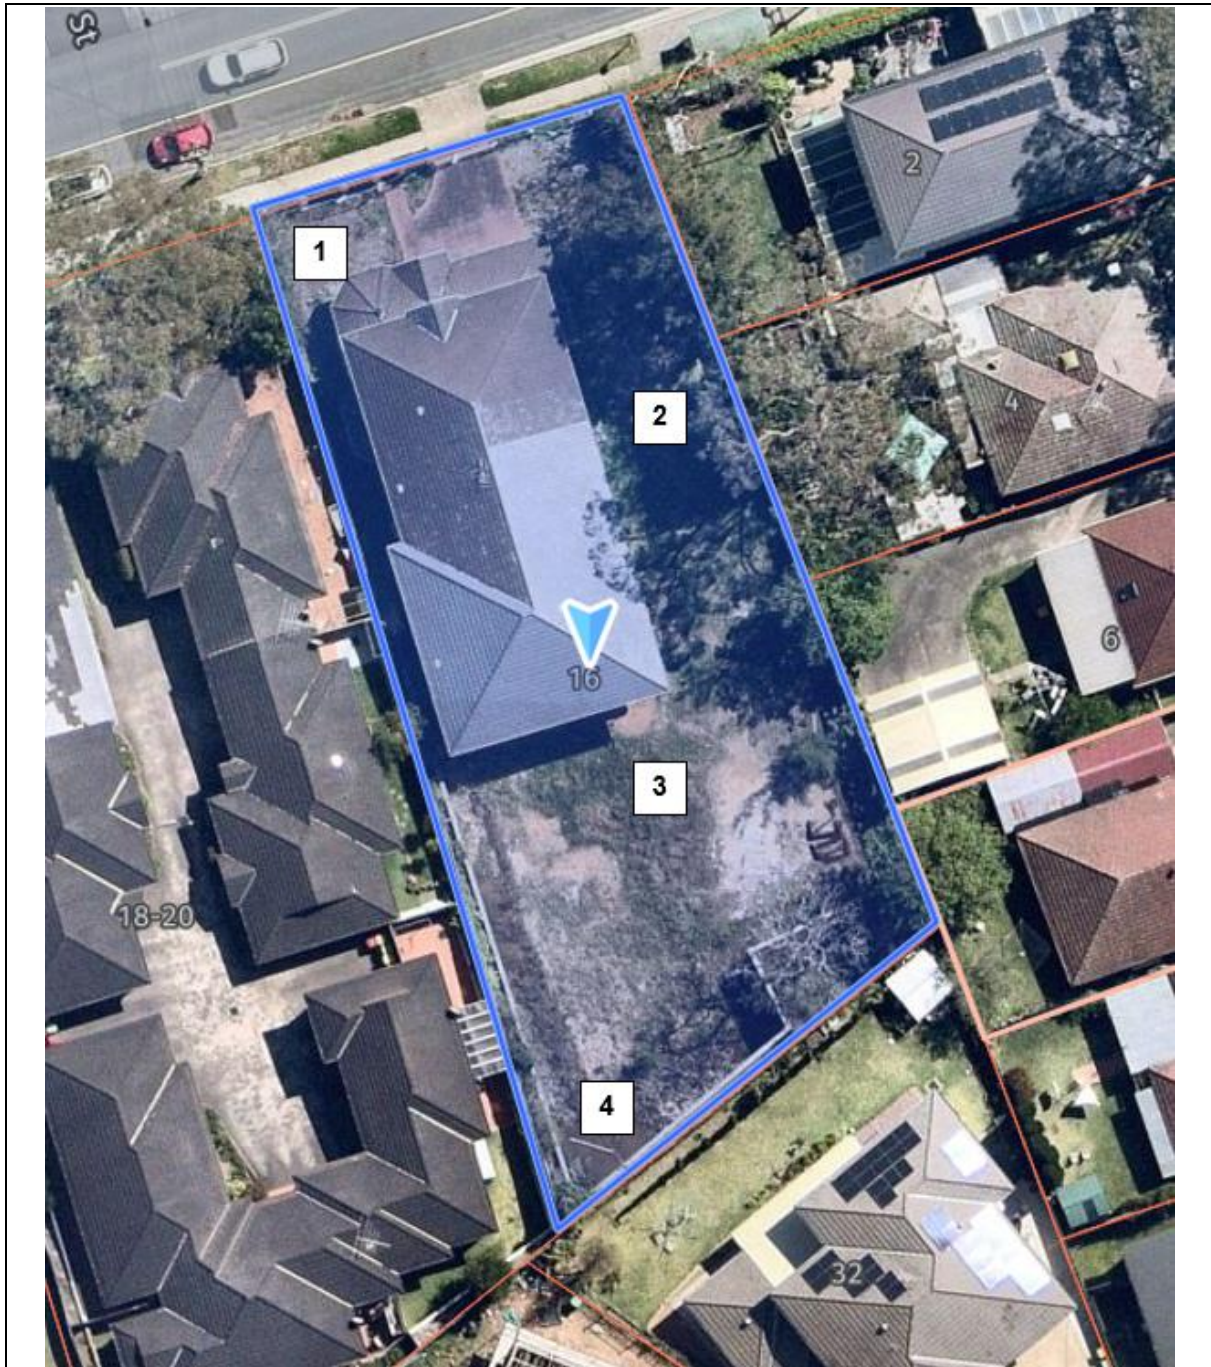
Figure 7.1 – Soil Inspection Locations

The four sampling locations are identified as BH-01 to BH-04 in Figure 7.1, on the following page.

The four sampling locations were selected to provide a sampling distribution considered to be practical and appropriate for a preliminary site investigation.
